3.0 Sherwood

Sherwood Site Long-Term Custody Compliance Requirements

Sherwood Site Inspection Results

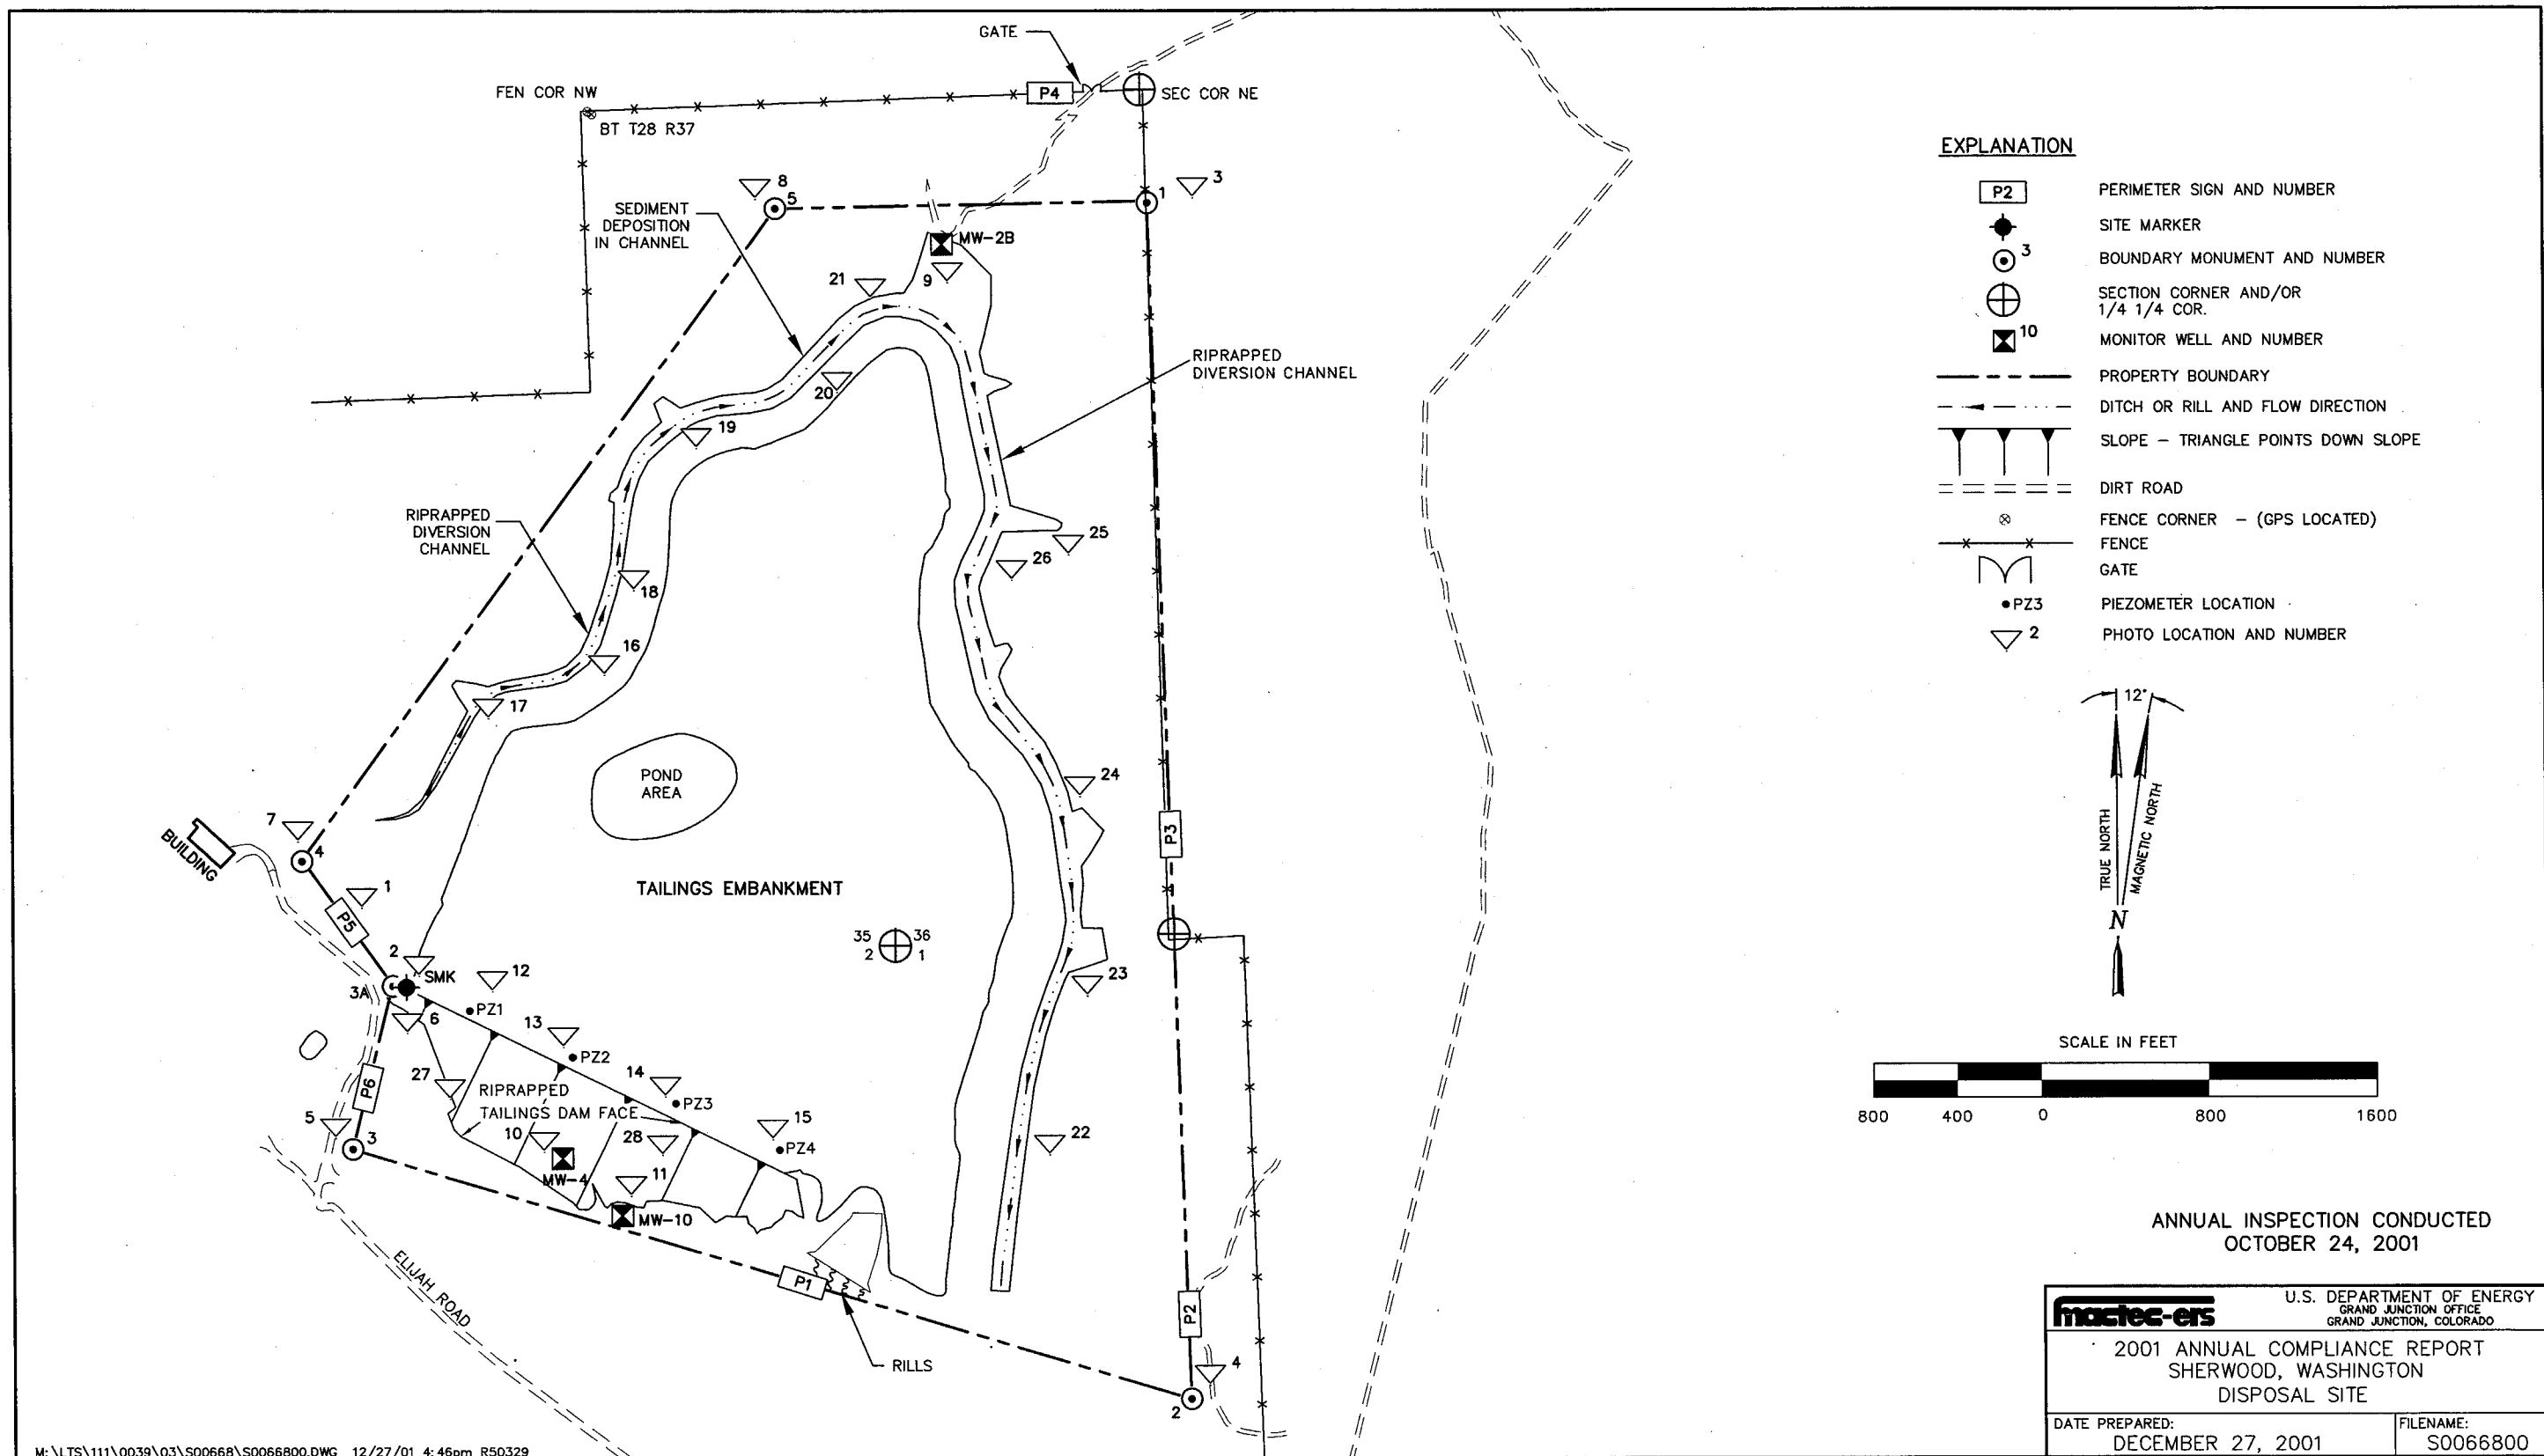
Figure 3-1. Sherwood, Washington, 2001 Inspection Drawing

Six perimeter or warning signs, designated P1 through P6, are placed at likely access points around the site property. The signs are attached at a height of about 5 feet above ground to steel posts set in concrete. Perimeter sign P4, north of the site, was placed at a fence boundary north of the actual site boundary along the old two-track road that approaches the site from the northeast. A typical perimeter sign is shown in photograph PL–1.

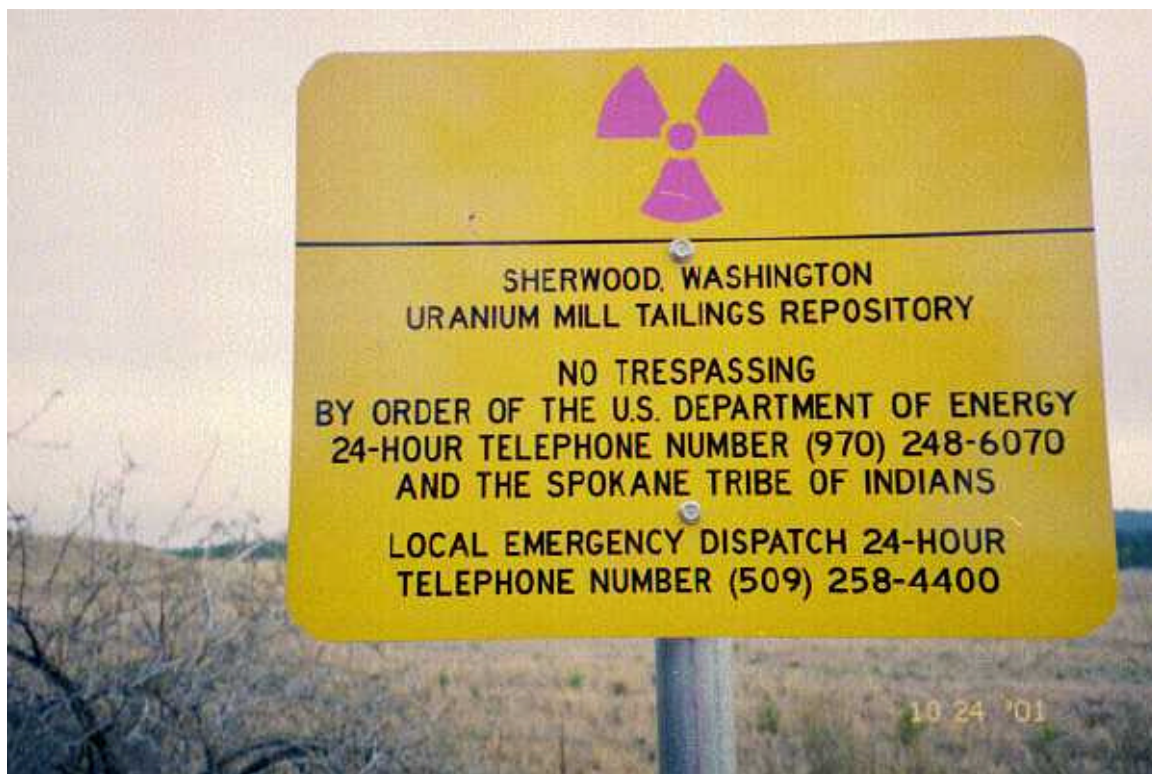
SHE 10/2001. PL-1. Typical perimeter sign.

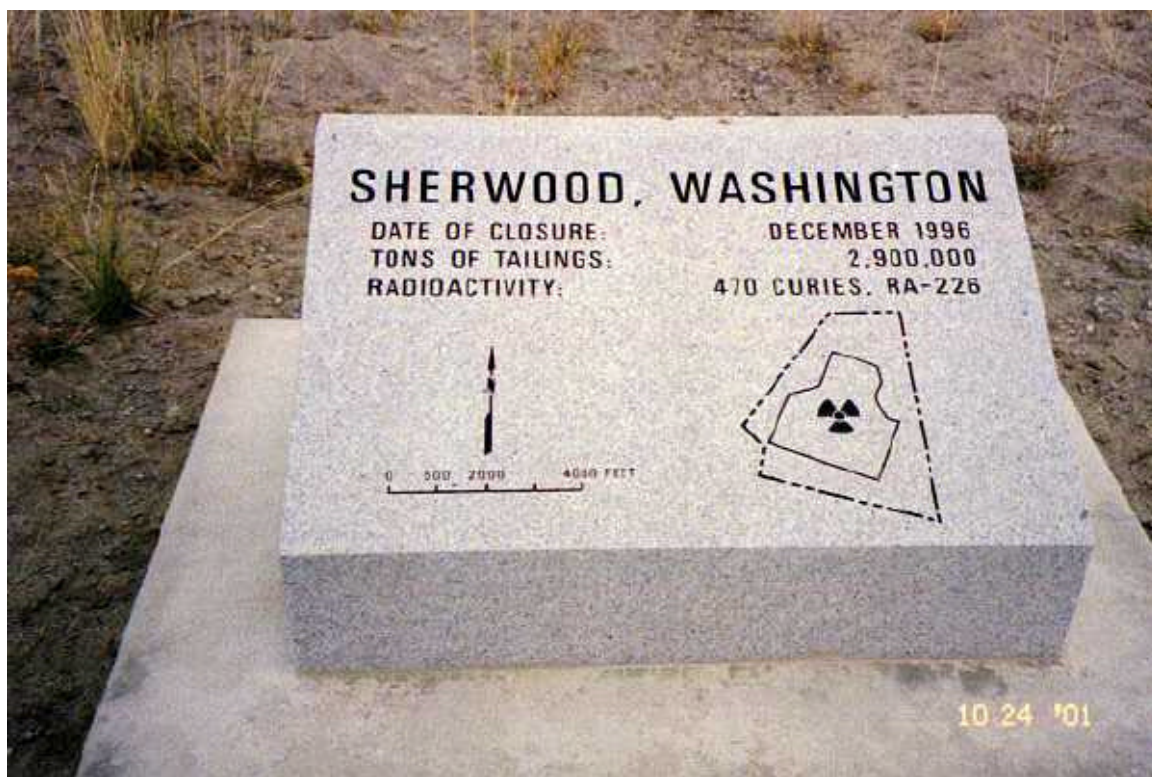
One inscribed granite site marker (PL–2) is present on the site near the southwest boundary of the site property where the access road lies closest to the site boundary. The marker is in excellent condition.

SHE 10/2001. PL-2. Site Marker.

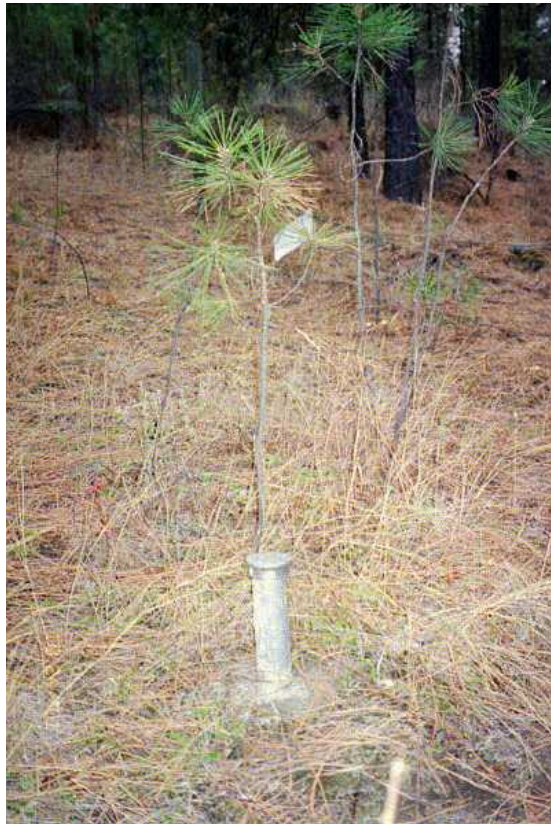
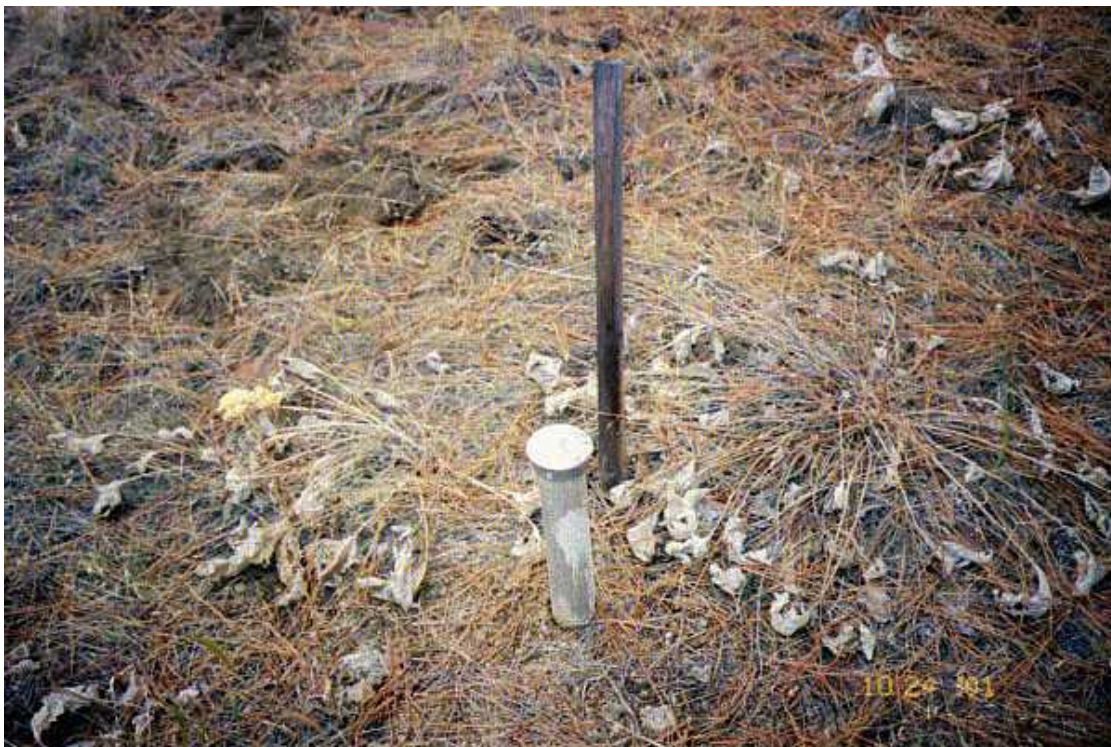
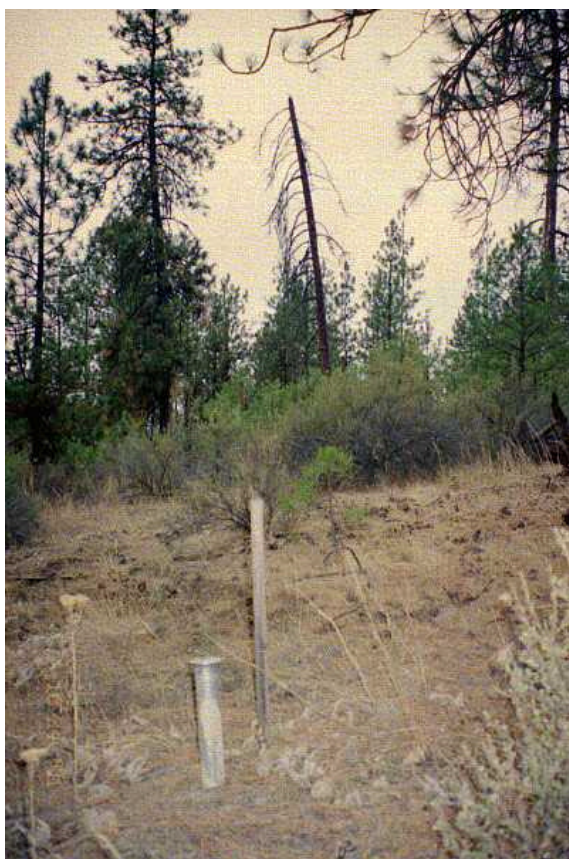
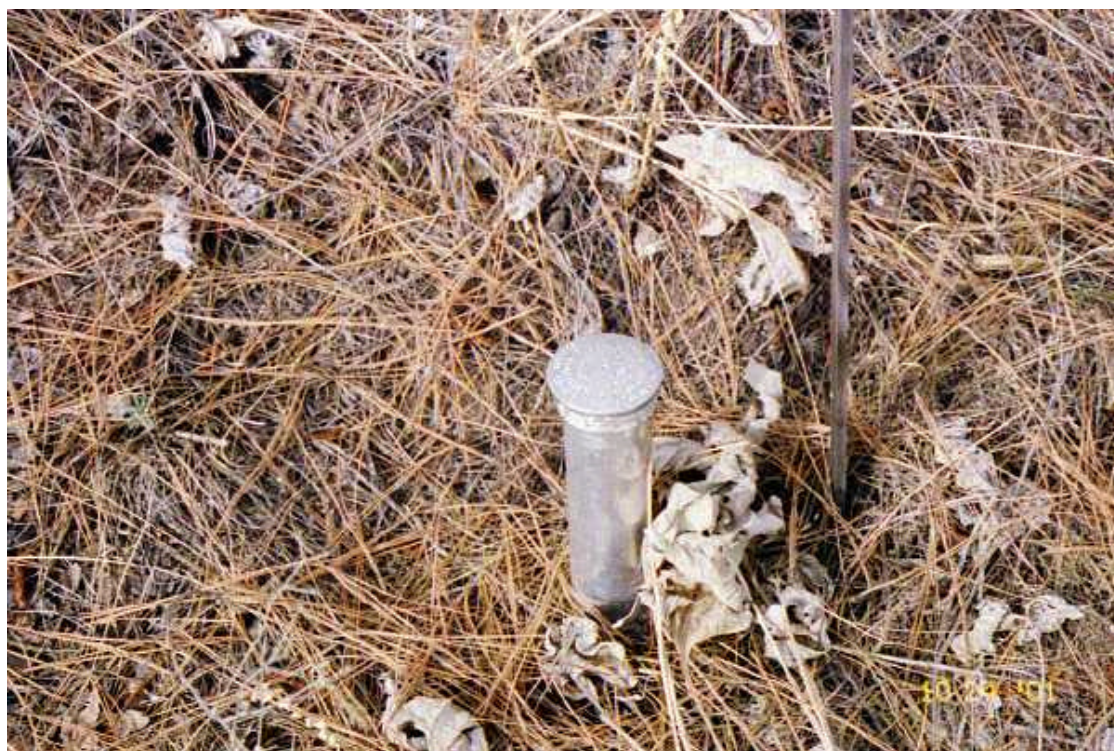
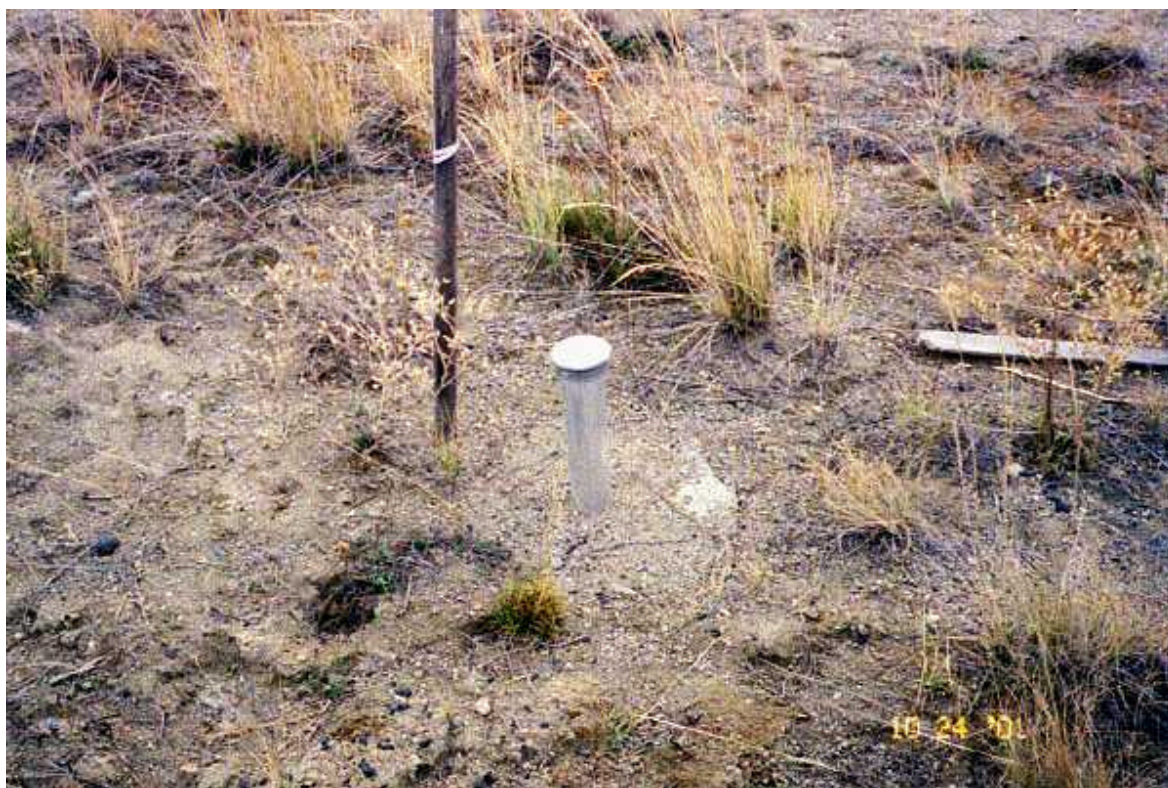
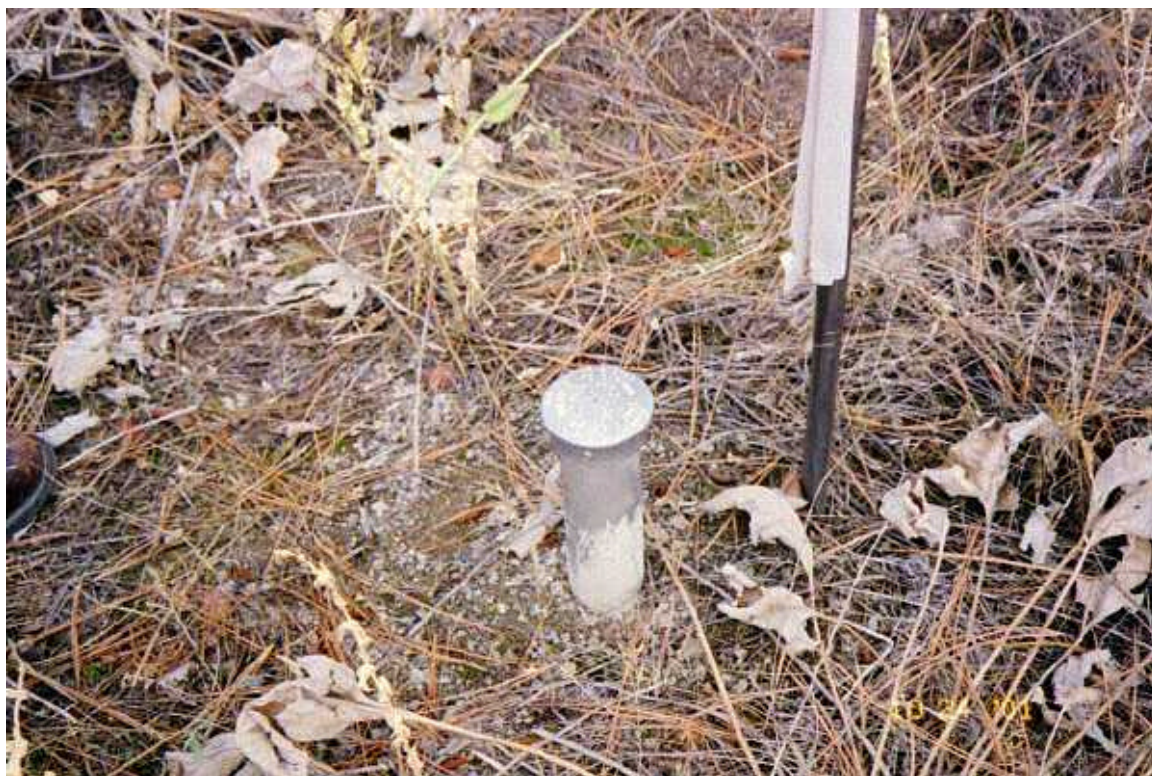
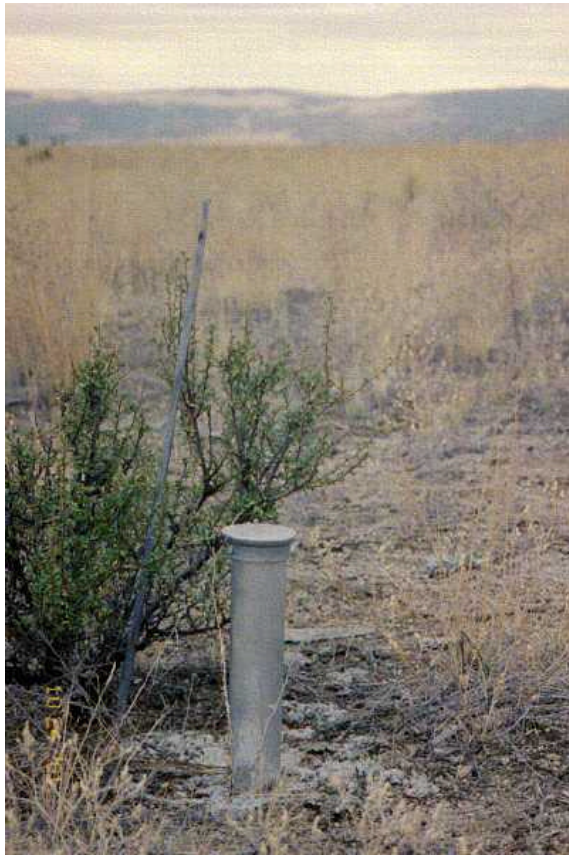
Six boundary monuments designated BM–1, BM–2, BM–3, BM–3A, BM–4, and BM–5 define the site boundary. The monuments are shown in photographs PL–3 through PL–8. The monuments are all in new condition.

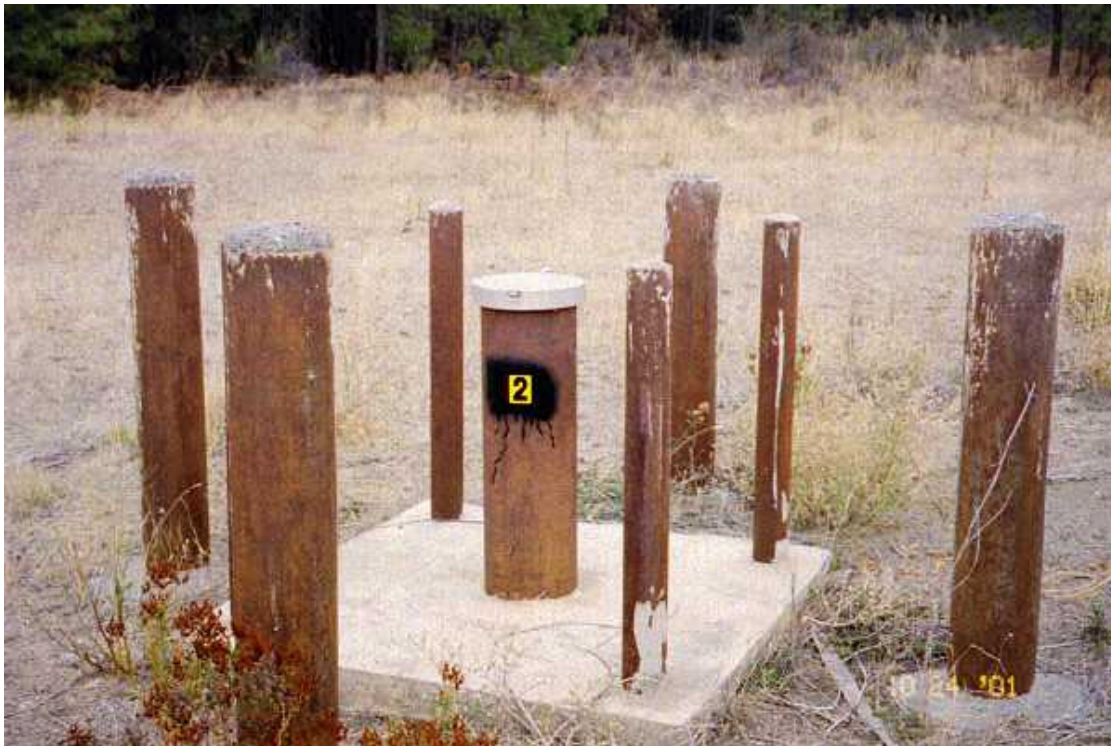
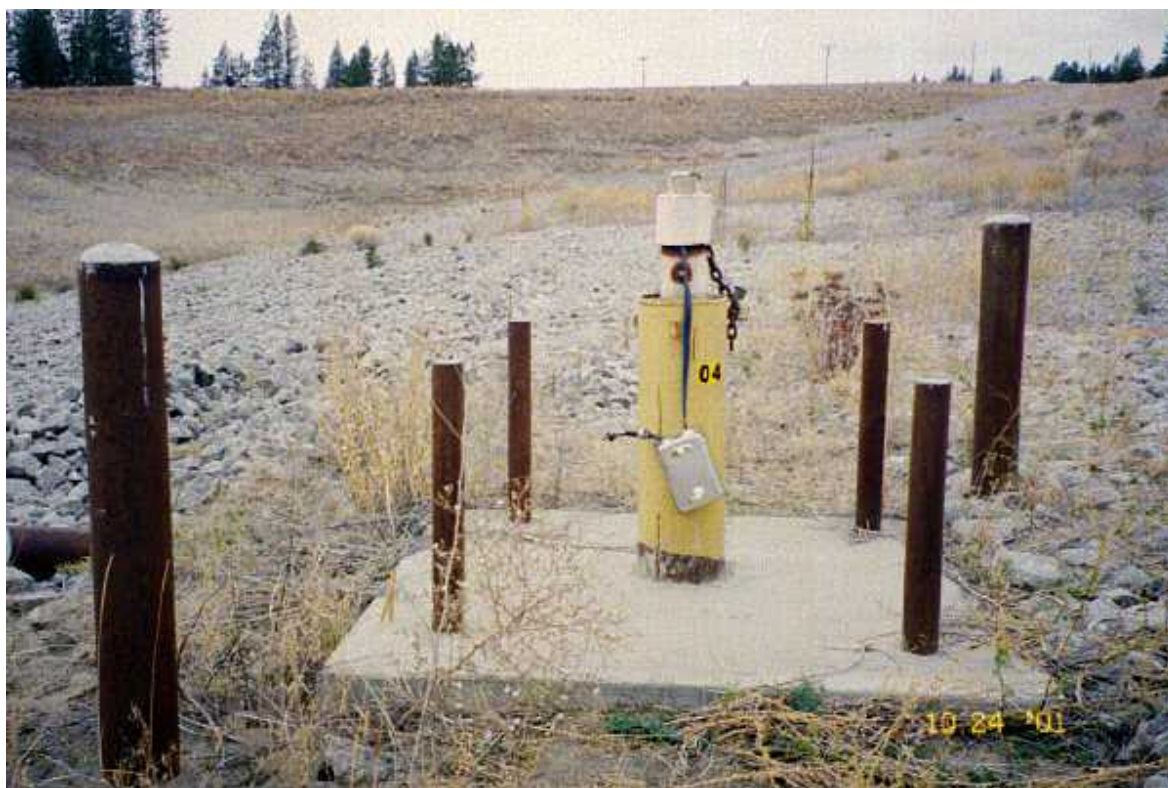
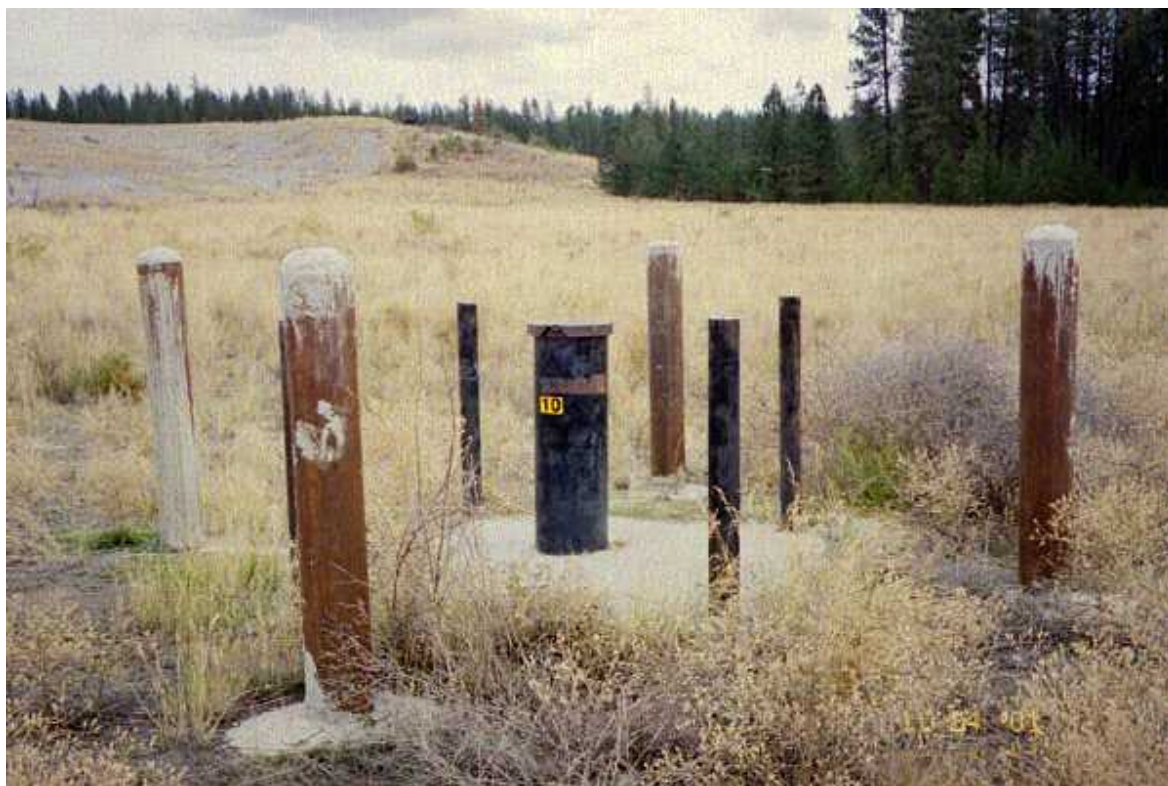
There are three monitor wells at the Sherwood site designated MW–2B, MW–4, and MW–10. The wells are shown in photographs PL–9, PL–10, and PL–11, respectively. MW–2B is the up gradient or background well. MW–4 and MW–10 are point-of-compliance wells. These three wells are sampled for sulfate, chloride, and total dissolved solids annually as a best management practice. All results from the July 2001 sampling event were within anticipated ranges and acceptable limits.

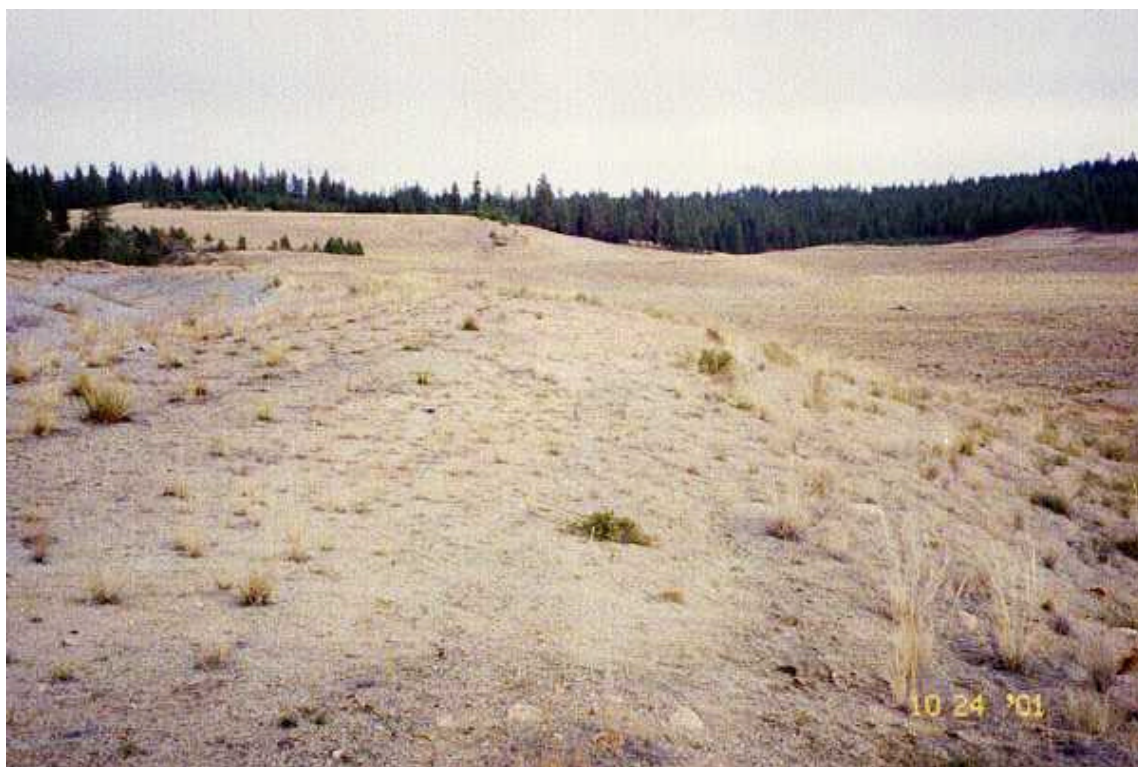
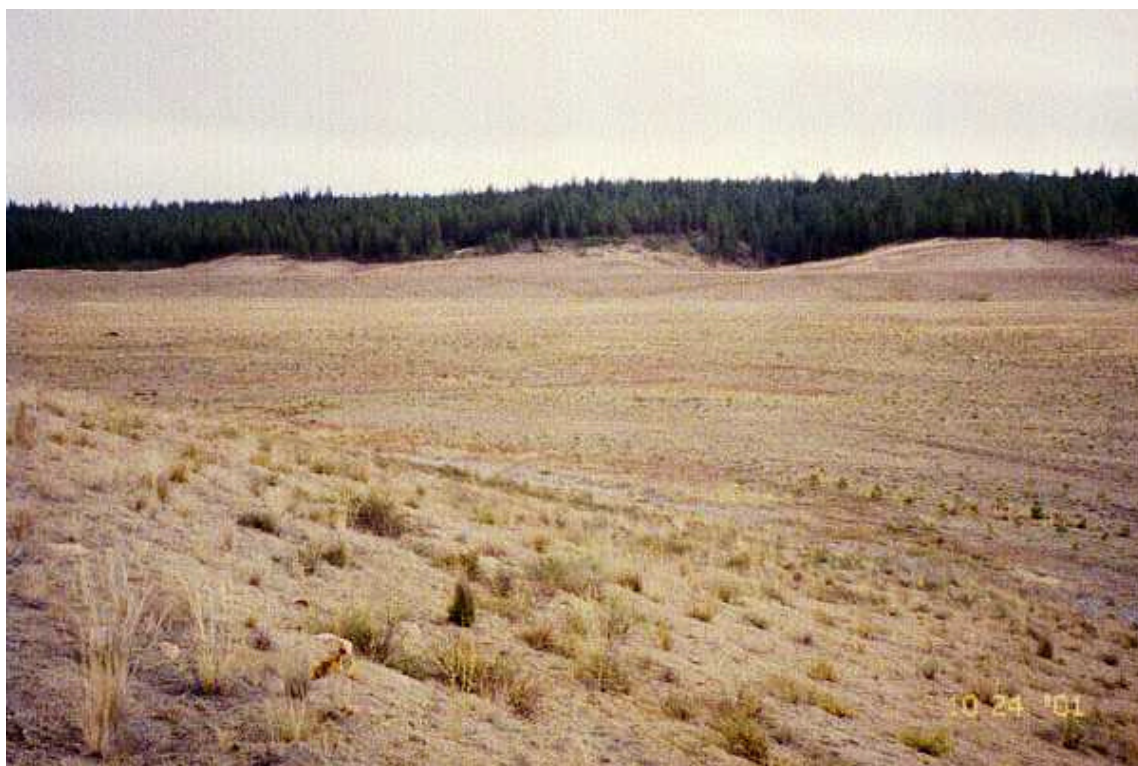
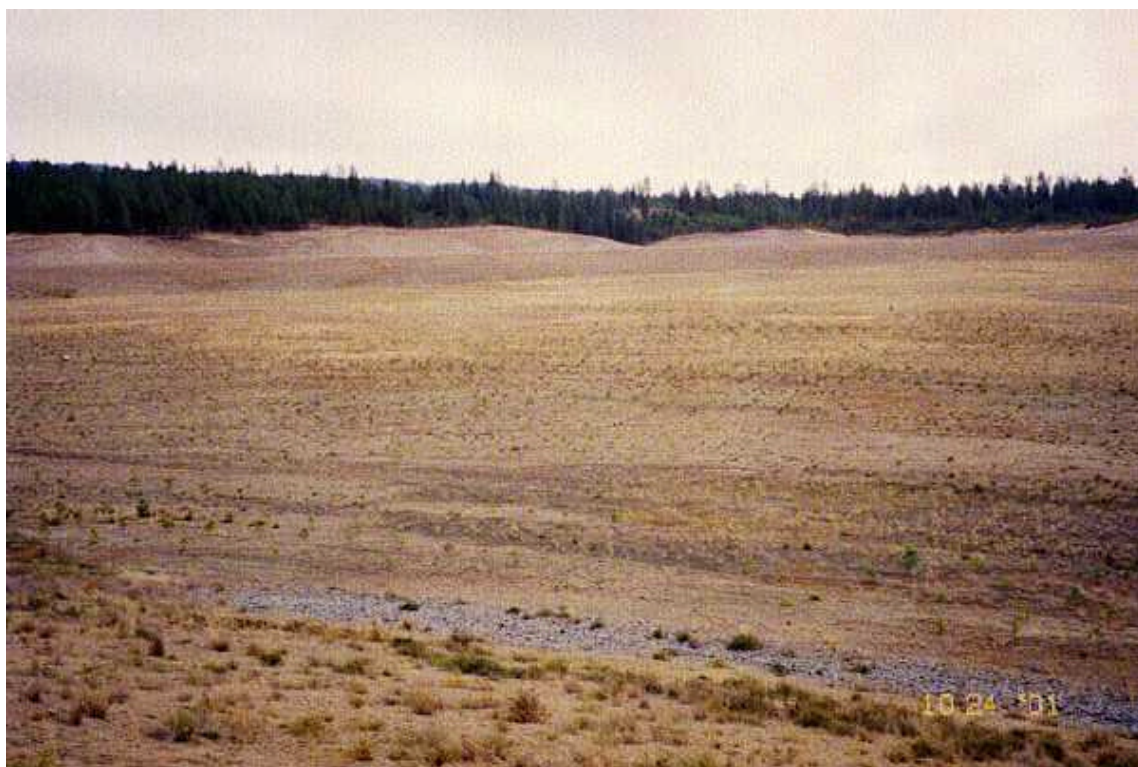
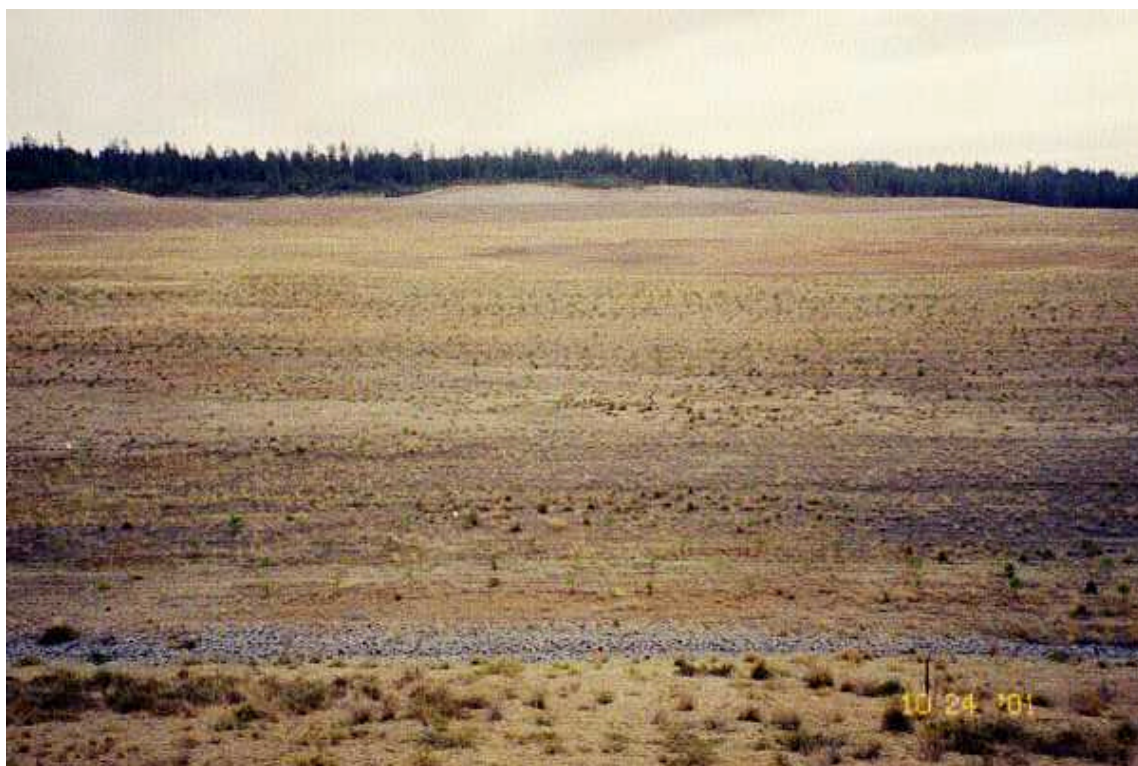
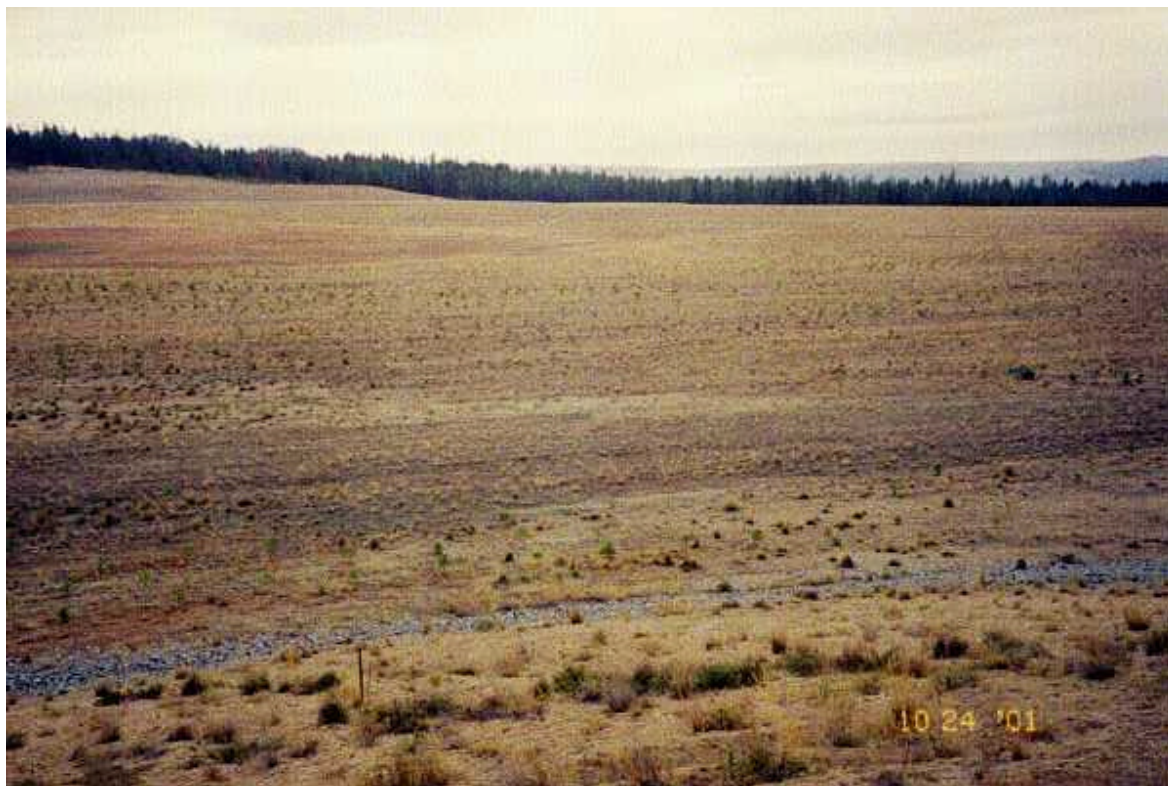
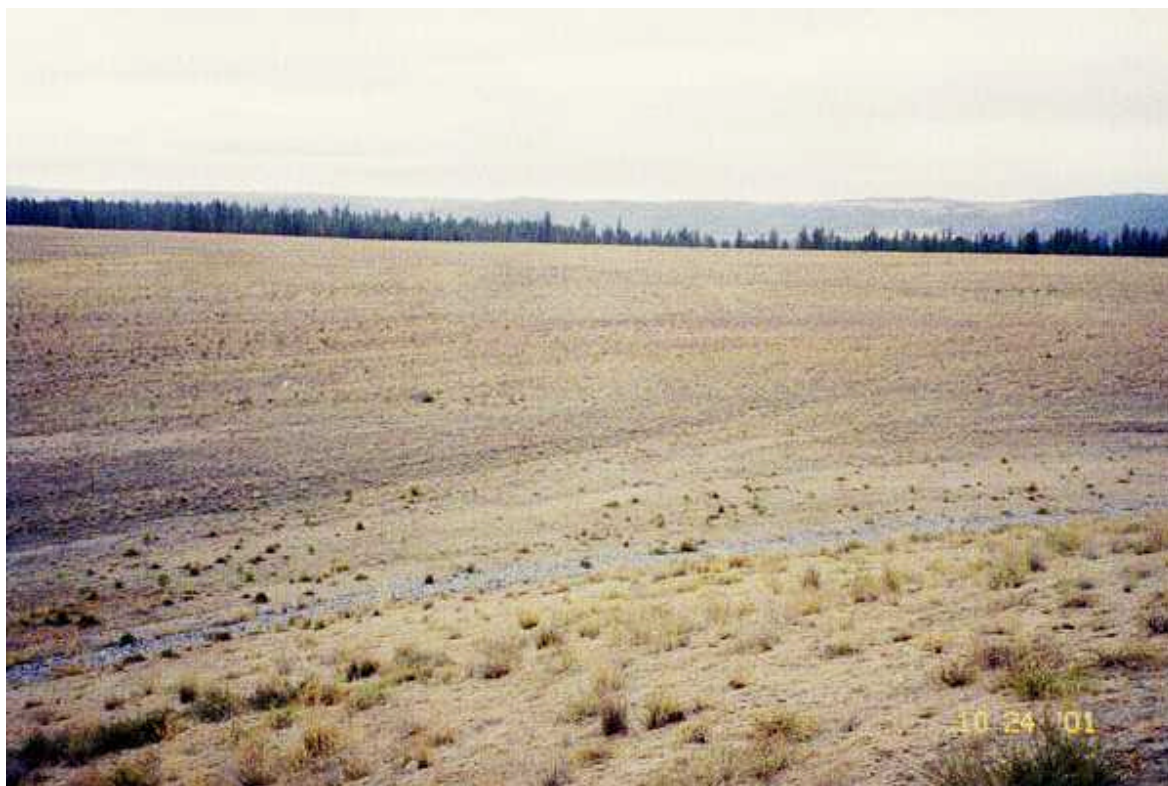
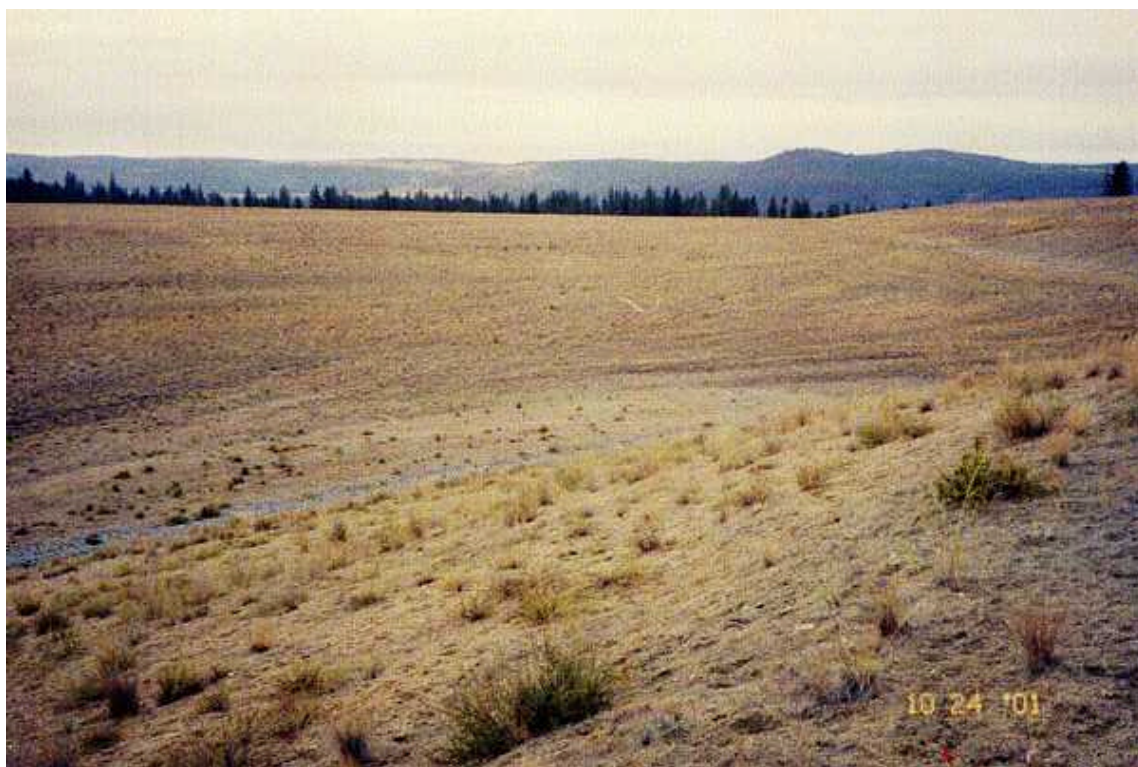
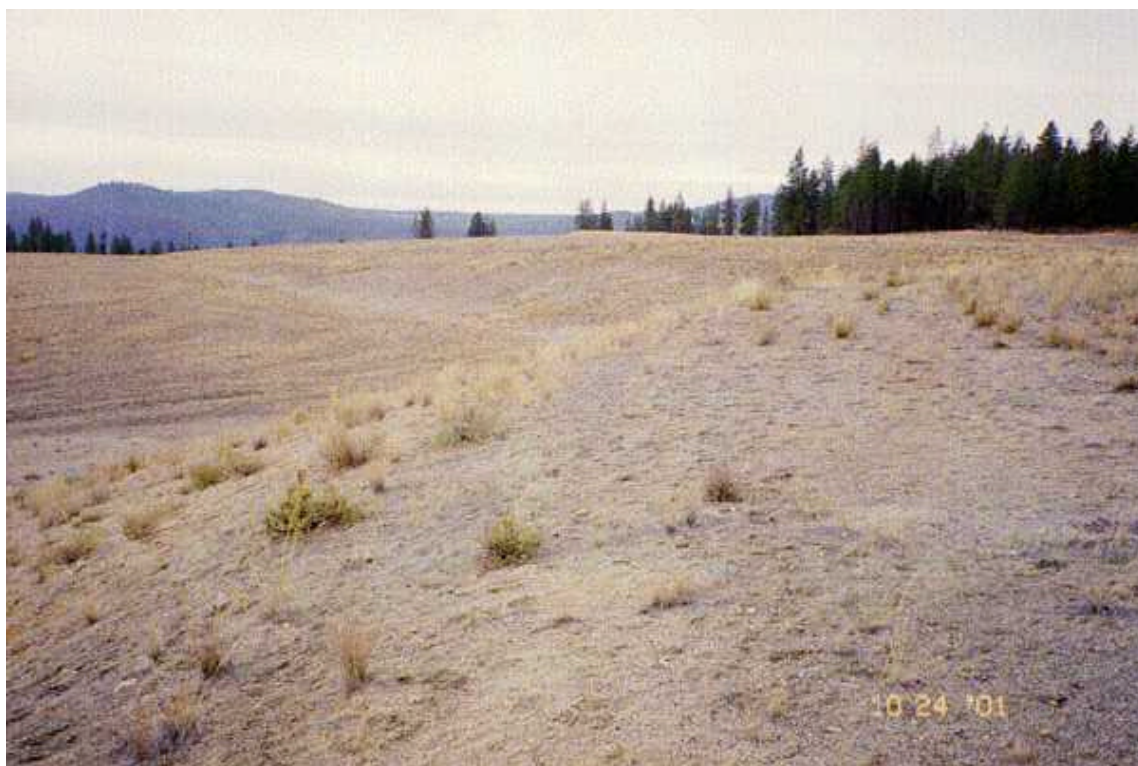
The tailings impoundment cover for the Sherwood site consists of 12 to 20 feet of uncompacted soils. Trees, shrubs, forbs, and grasses have been planted on the cover to accelerate the revegetation of the disturbed cover soils. A panoramic overview of the tailings impoundment cover is shown in photographs PL-16A through PL-16H. Inspectors walked parallel traverses across the impoundment cover to inspect this transect. There was no evidence of differential settlement other than the pond area observed during earlier orientation inspections. The pond area did not appear to have expanded in size.

In general vegetation is becoming well established. As is typical, some areas are progressing faster than other areas. The pond area was dry at the time of the inspection; however, the plant species present indicate that there is year-round moisture below the surface. Vegetation in the pond area is composed primarily of native wetland species such as hardstem bulrush (*Scirpus acutus*), Olney threesquare (*Scirpus americanus*), common spikerush (*Eliocharis palustris*), sandbar willow (*Salix exigua*), and plantain (*Plantago eriopoda*). The pond provides habitat for small mammals, birds, and reptiles and appears to be a water source for larger mammals such as deer and elk, whose sign was abundant in this area.
